# Mobile Intel® Pentium® 4 Processor-M

Specification Update

*October 2004*

Document Number: 250721-026

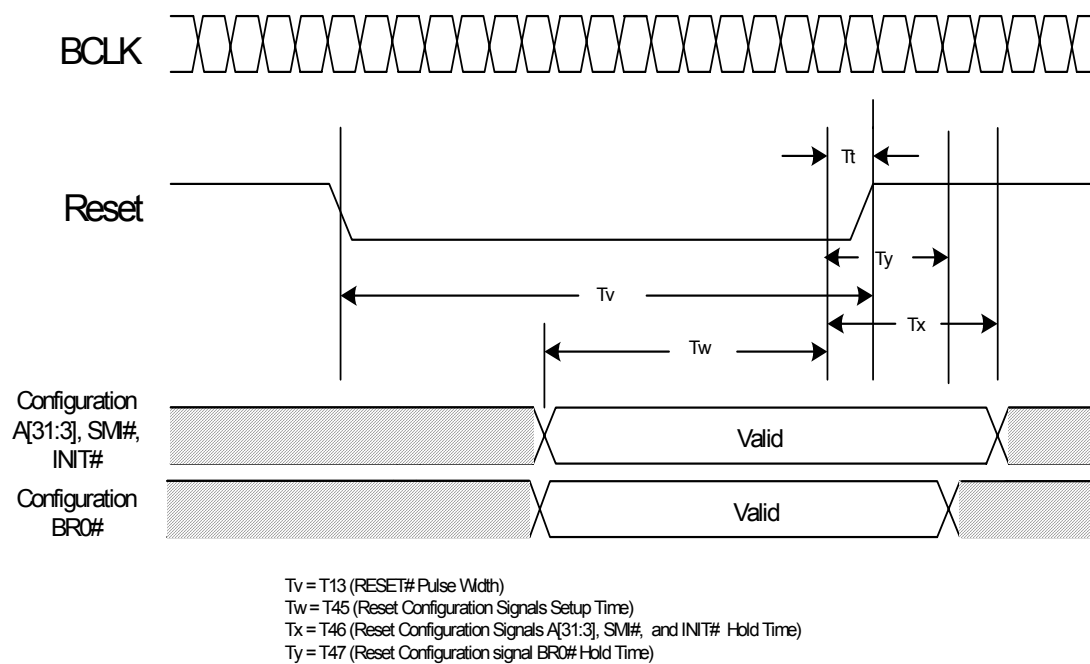
**Figure 13. System Bus Reset and Configuration Timings**

The BR0# maximum hold time has changed to 2 BCLKs. This change will be shown in the “System Bus AC Specifications (Reset Conditions)” table and “System Bus Reset and Configuration Timings” figure of the *Mobile Intel® Pentium® 4 Processor - M Datasheet*. This change will be incorporated in the next revision of the datasheet.

The following figure will be modified to reflect this change:
